Rapid Stabilization of Thawing Soils for Enhanced Vehicle Mobility

A Field Demonstration Project

Maureen A. Kestler, Sally A. Shoop, Karen S. Henry,
Jeffrey A. Stark, and Rosa T. Affleck

February 1999

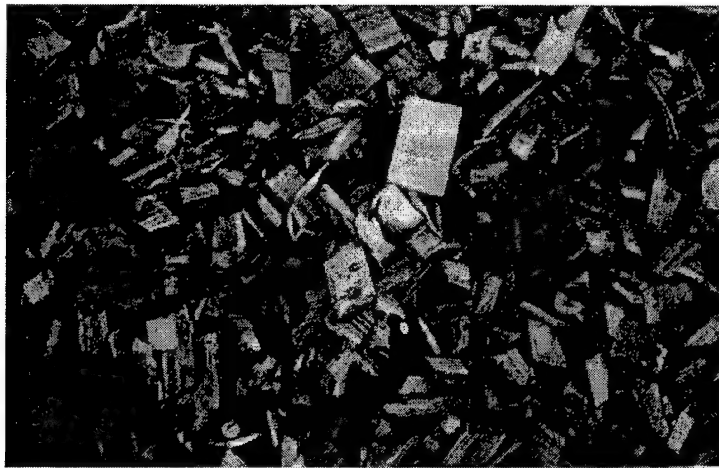
a. Chunkwood fill.

Figure 8. Chunkwood.

The chunkwood was produced by shredding whole trees with a USFS prototype wood chunking machine. The resulting wood chunks were approximately 3.8 cm (1.5 in.) thick and were well graded, ranging from 1 to 20 cm (0.5 to 8 in.) in diameter. The chunkwood was mixed with sand in the approximate ratio of three parts chunkwood to one part sand. The density of the chunkwood/sand mix was approximately 796 kg/m³ (50 lb/ft³). The bulking factor appeared to be low. Although testing by the USFS has shown a sheepsfoot or padfoot roller improves compaction, the chunkwood compacted easily with construction vehicle traffic. The compacted surface was relatively smooth and provided a good wear surface (Fig. 8).

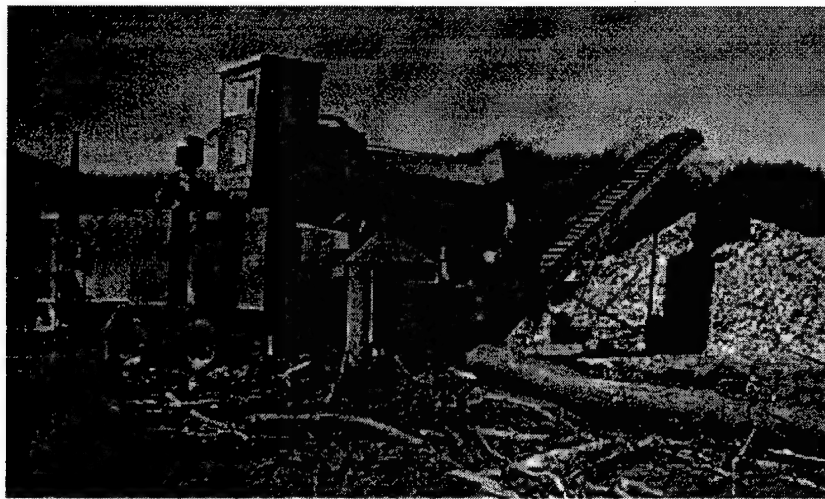
b. USDA Forest Service wood chucker.

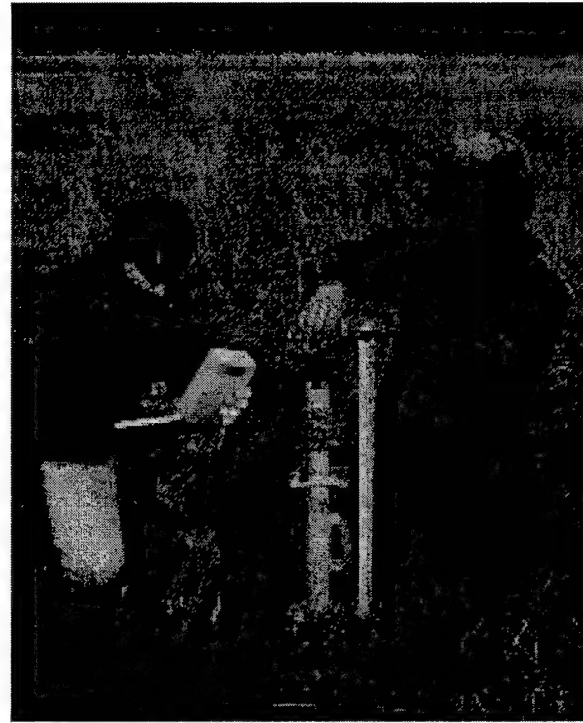
b. Clegg impact tester (CIT).

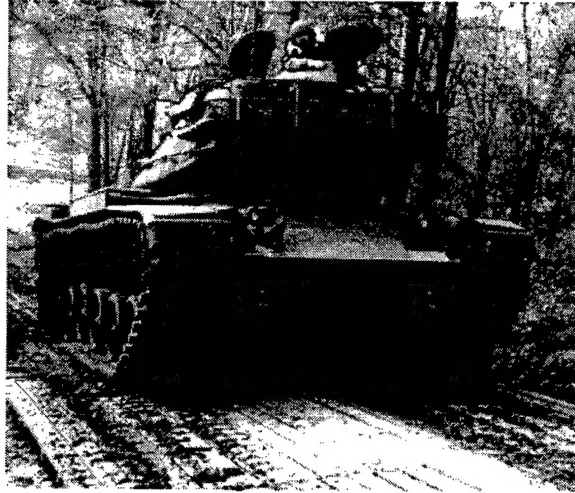
Specifications for the M60A3 Tank	
Crew	4
Combat weight	51,500 kg
Unloaded weight	47,500 kg
Power-to-weight ratio	14.56 bhp/tonne
Ground pressure	0.85 kg/cm ²
Length gun forwards	9.436 m
Length hull	6.946 m
Width	3.631 m
Height	3.27 m
Firing height	2.095 m
Ground clearance	0.45 m
Track	2.921 m
Track width	711 mm
Track adjustment	Hydraulic
Track type	T142 replaceable pads
Length of track on ground	4.235 m
Max road speed	48.28 km/h
Fuel capacity	1420 liters
Max road range	480 km
Fording	1.22 m
Fording with preparation	2.4 m
Gradient	60%
Side slope	30%
Vertical obstacle	0.914 m
Trench	2.59 m
Engine	AVDS-1790-2D
Suspension	Torsion bar

a. M60A1 Tank.
